METHODOLOGY AND EFFECTIVENESS OF
DRAINAGE SYSTEMS FOR AIRFIELD PAVEMENTS

TECHNICAL REPORT C-13

Systems Approach to Life-Cycle Design of Pavements

by
Harry R. Cedergren

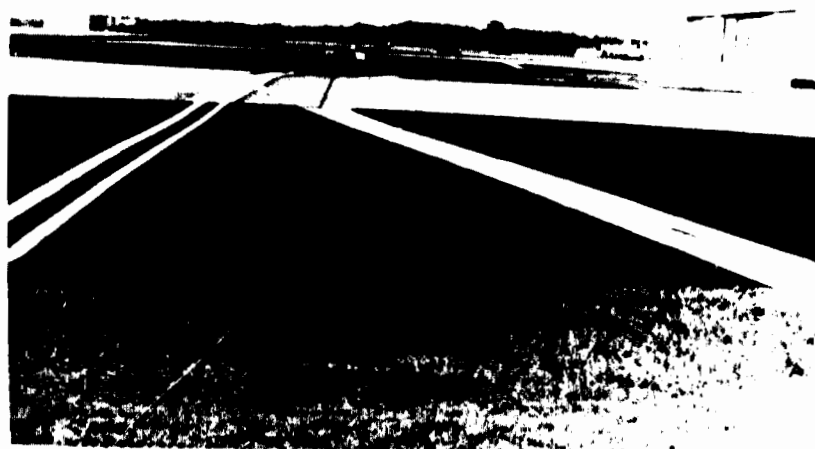
Figure B-2. Low, cross view showing crown of a dock area; it has good cross slope for surface drainage.

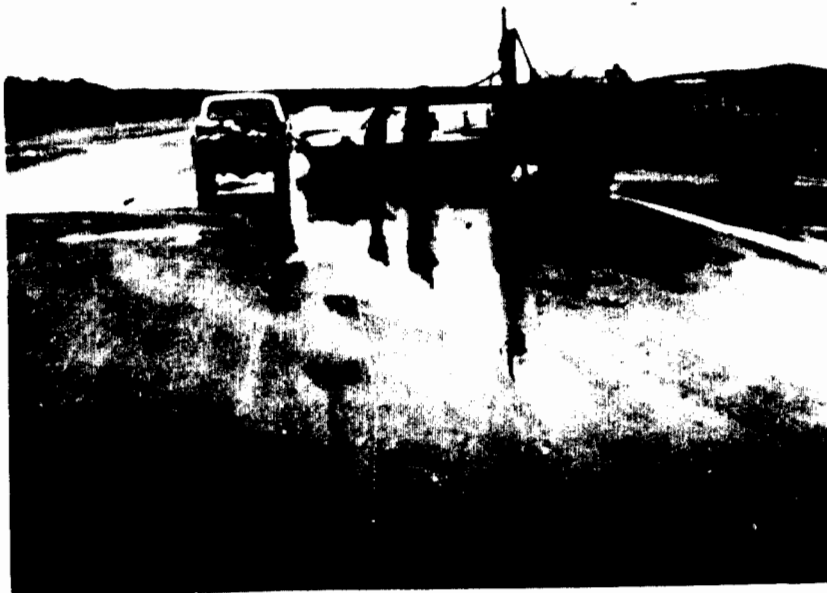
Figure D-2. Photo of drilling equipment at Well 1; near centerline of Taxiway G at Calibration Hardstand; stopped raining about 2 hours ago; some water entrapment on surface of pavement.

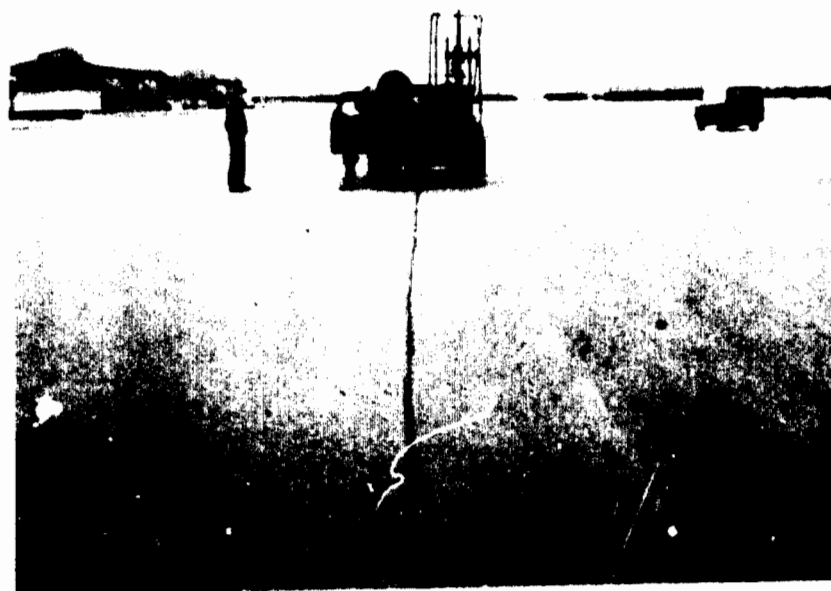
Figure D-3. Photo of drilling equipment at Well 4; Taxiway G at Dock 32; base course under 6-in. thick AC pavement is very open-graded trap rock.
